Authors: M. Bradford Henley, MD MBA and Anna Miller, MD (JUNE 2012)

Title: Internally rotated oblique x-ray to assess healing of distal tibial shaft fractures

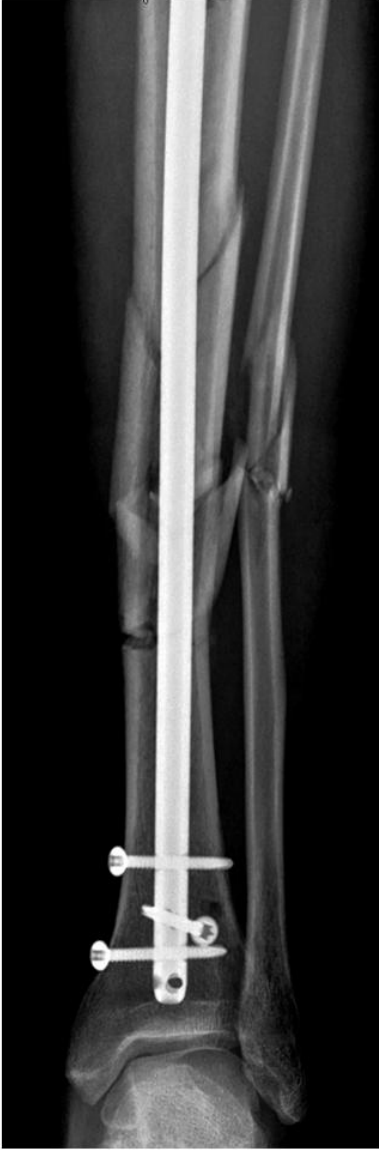
Figure 1a

FIGURE 1: Example of two views taken on the same date of service after nailing of a tibial fracture with segmental comminution.

Figure 1A is an AP view with little evident callus.

Our technical trick is imaging of the posterior-lateral cortex of the tibia specifically with an internal oblique radiograph to assess fracture healing in patients with tibial shaft fractures. Because of the destruction of the internal blood supply and the excellent blood supply near the interosseous membrane, the posterolateral tibia is often where healing is visualized first; this is best assessed on the internal rotation oblique view. In addition, this area can be a harbinger of poor healing if fracture callus is not seen on this view by 8-12 weeks post injury. Our recommended series of radiographs for post-operative evaluation of tibia fractures includes an anteroposterior, lateral and internal rotation oblique radiograph (FIGURE 3).

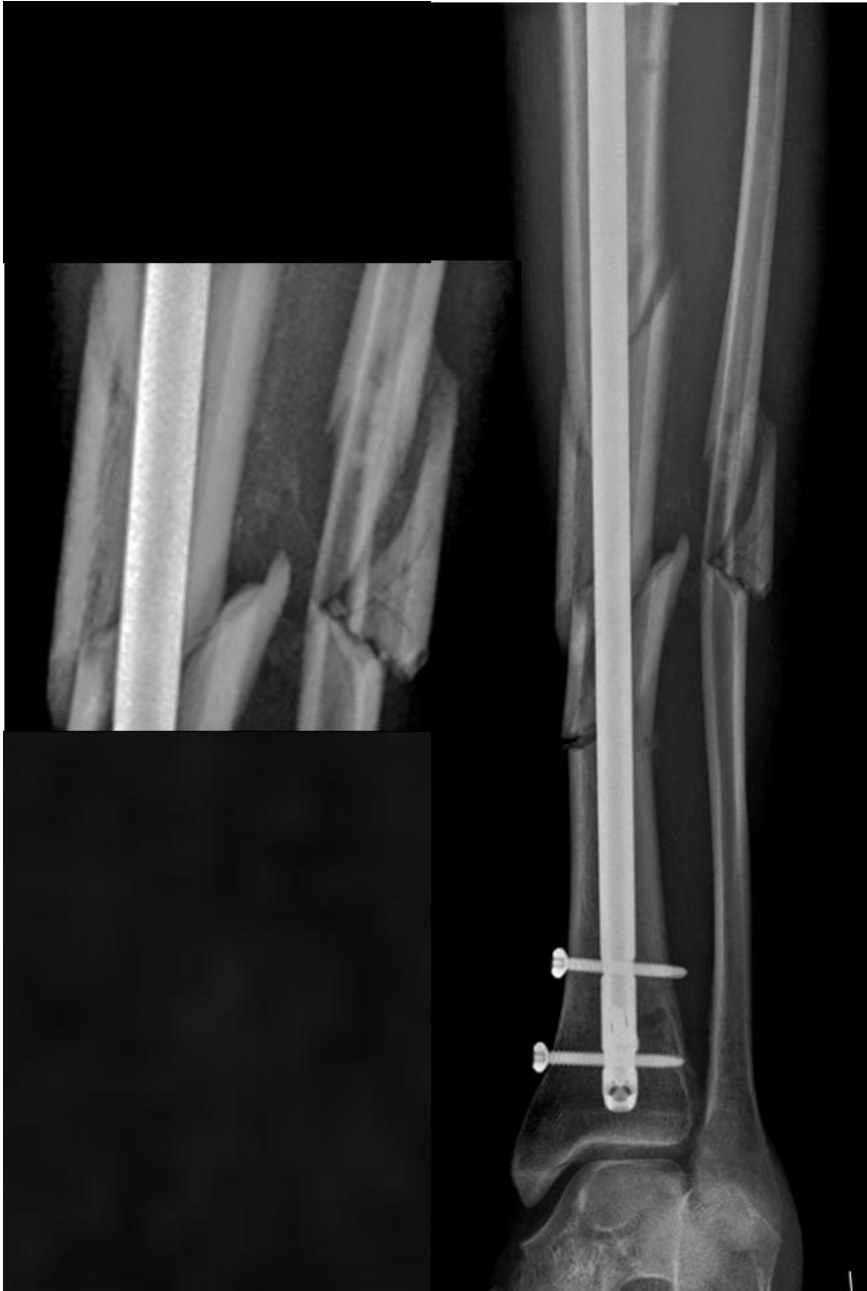
Figure 1b

Figure 1B is an internally rotated oblique that demonstrates the presence of abundant early callus, clearly seen on the smaller close-up image.
